# *Michael Rucker Professional Inspector LLC*

## Property Inspection Report

Date of Inspection: 8/26/2017 Time: 9:00 AM  
Age of Home: 2017 Size: 3993  
Weather: Cloudy 84 F  
Order ID: 248House faces east.

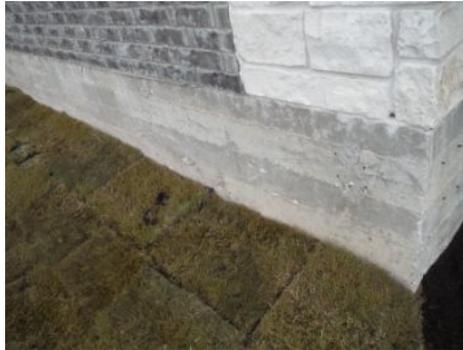
Missing parge coat.

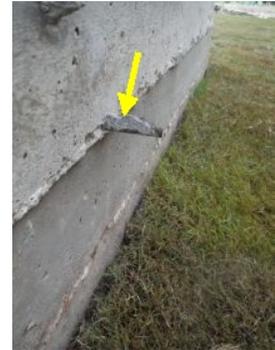
- Exposed reinforcement steel noted in slab at northwest side.

Exposed reinforcement steel

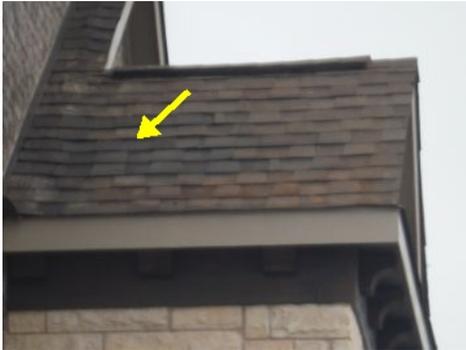
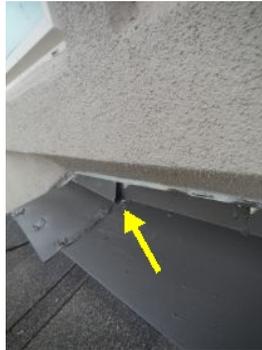
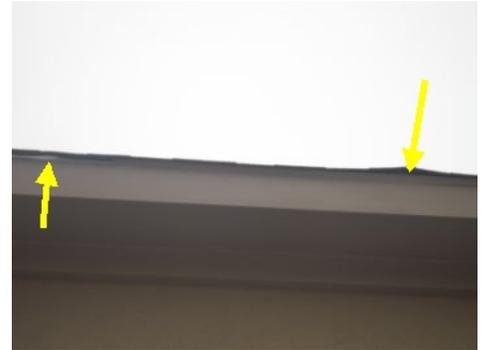
- Metal **drip edge** flashing appears to have been repaired or replaced on the southwest corner second floor. Numerous areas at roof edge with shingles pushed up. Recommend further investigation and make all necessary repairs to asphalt shingle covering at roof edge.

Shingles standing up and drip edge flashing appears to have been replaced.

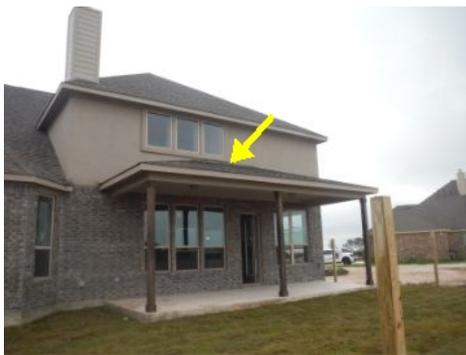
- Attic ventilation is marginal to poor at patio cover and attic area over garage, recommend improvement to ventilation to reduce possible moisture buildup in attic areas and promote better overall efficiency and function. Both areas do not have exhaust venting installed noted soffit vents for intake of air only.

No upper attic exhaust vents.

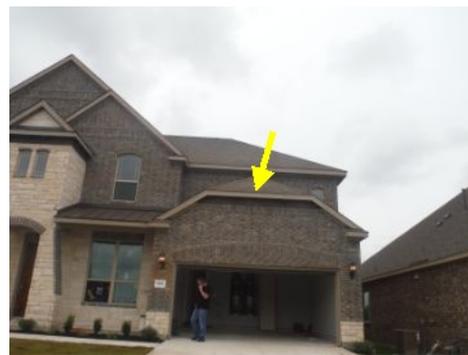
No upper attic exhaust vents.

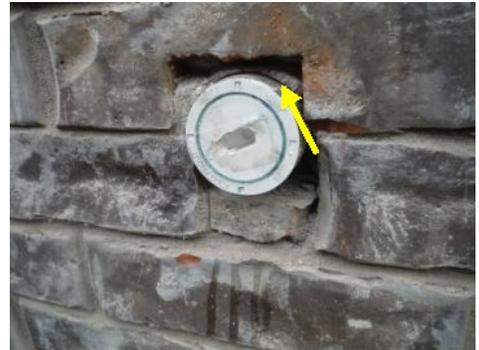
Combustion air for chimney.

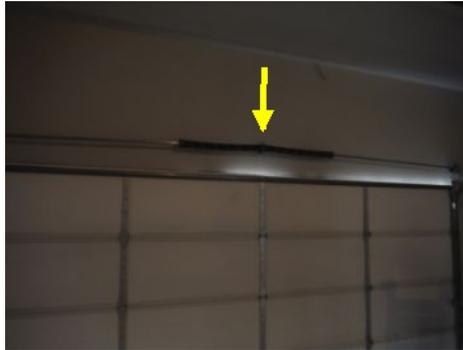
Tension bar does not appear level.

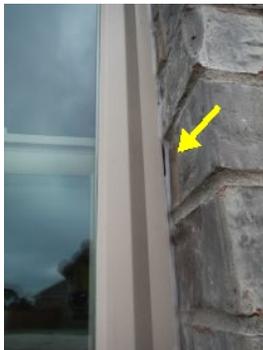
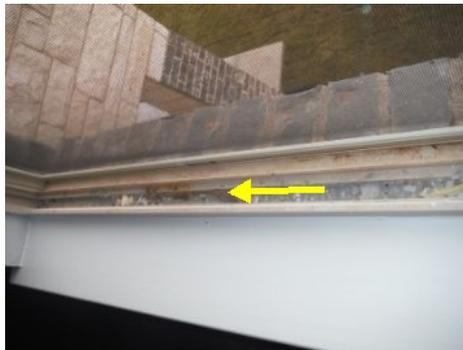
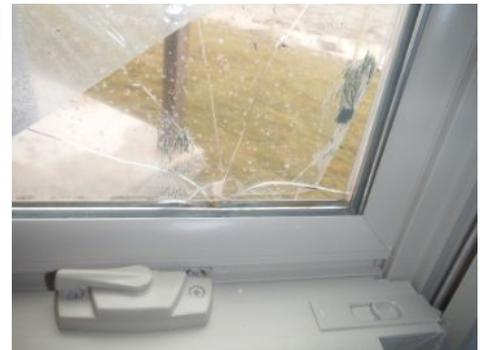
- Window at master bedroom is broken or cracked. Recommend repairing or replacing for proper operation.
- Numerous windows located on east side of structure with excessive debris located inside window case.
- Gaps or missing caulking/mortar noted around the window frame(s) at numerous exterior windows. Recommend repairing this condition as needed to promote proper weather seal and efficiency.

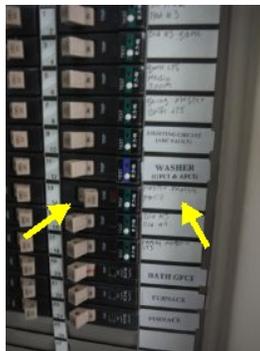
• Arch fault breaker would not reset.

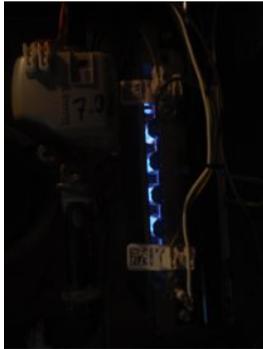
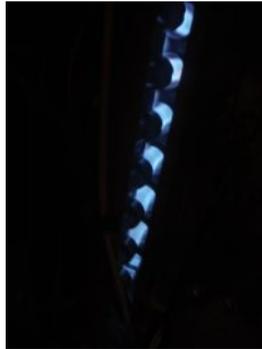
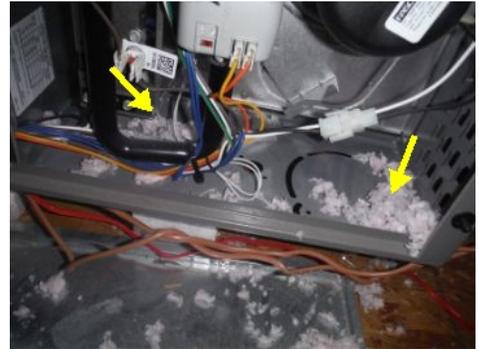
• **Insulation debris noted inside one of the gas fired furnaces located in attic. Recommend cleaning all debris out for fire safety.**

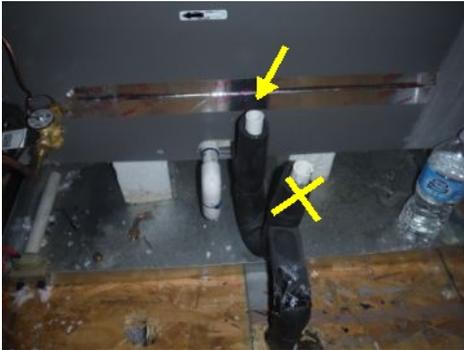
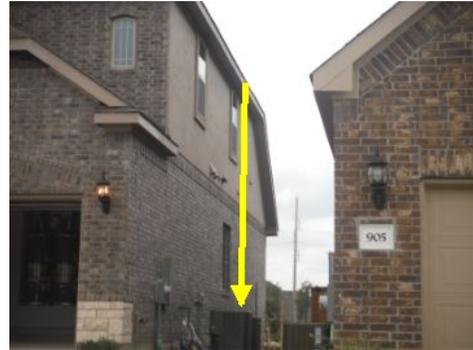
• **No rain diverter or rain gutters installed and units are directly under the eave. Recommend repairing per manufactures installation instructions. Most manufactures consider this installation as a corrosive environment and may void warranty.**

• **Recommend installing cap on primary condensate drain trap clean out port. Do not cap vent port downstream of primary condensate trap.**

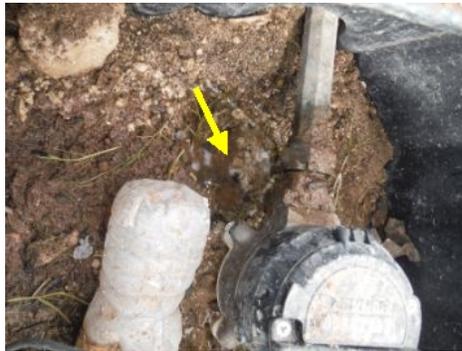
- Water pressure tested at 60 psi.
- **Leak noted at water meter connection. Recommend plumber evaluate and repair as needed.**

Leak.

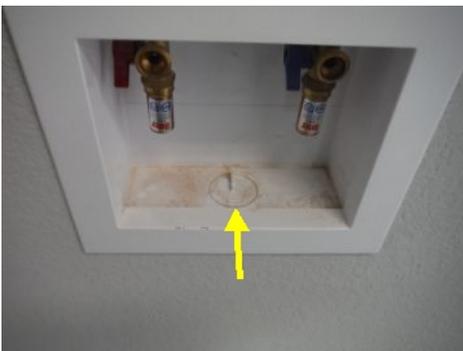
Drain plug still in place at laundry.

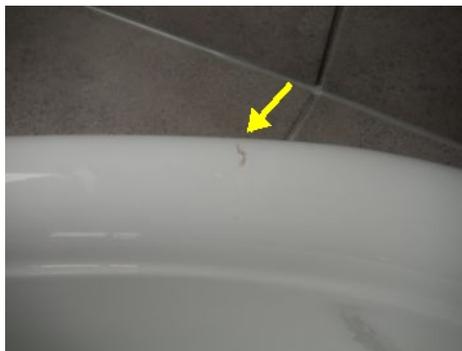
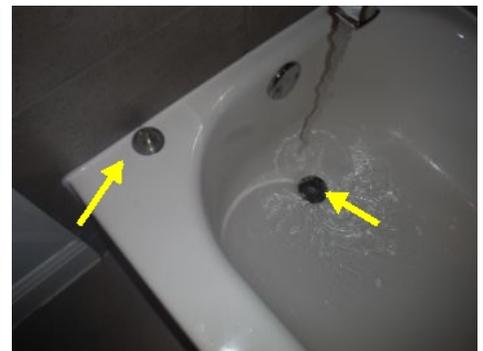
Drain stop not installed.

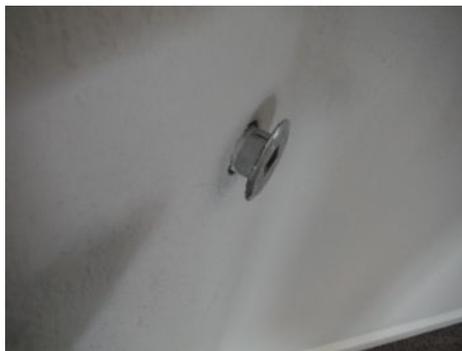
- Appears gas main line at gas meter is electrically bonded as required.
- Gas valve at chimney is not flush with the wall.

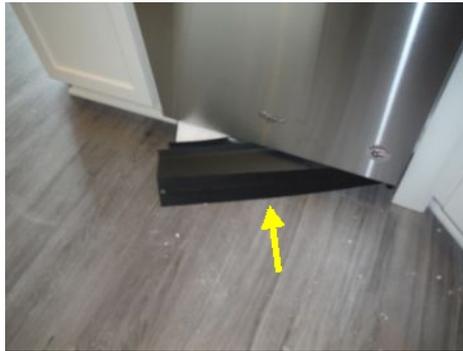
- Dishwasher is a Whirlpool. Unit completed a complete cycle and appears to be operating with in normal parameters at the time of the inspection.
- **Kick plate is not properly installed.**

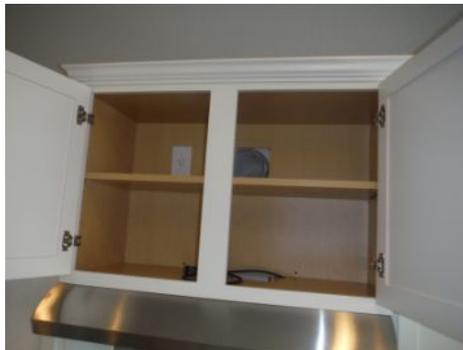
- **Kitchen exhaust fan is not operational. Exhaust duct not plumbed to the exterior. Recommend contractor evaluate to determine the cause of the malfunction and repair or replace as needed.**

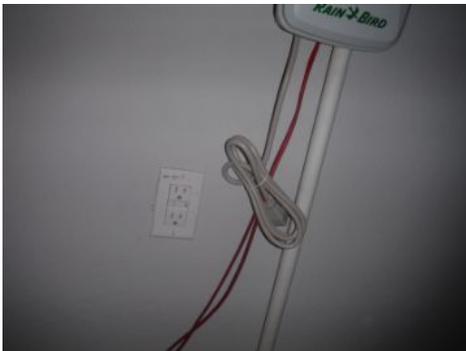
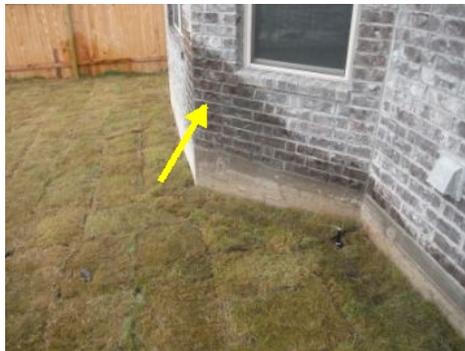
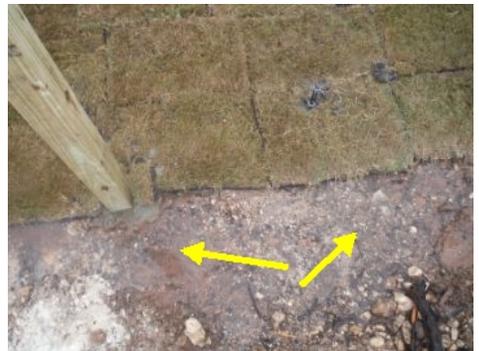
- Head located in back yard appears to be leaking or not properly operating standing water next to head noted.
- Recommend labeling zones for maintenance.

Appears head is leaking or not properly operating.

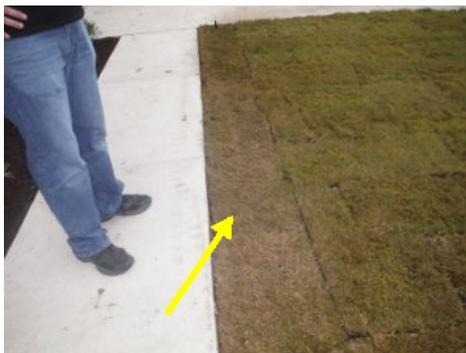
- Sprinkler system consists of 6 zones.
- Back flow preventer or double check valve located at southeast corner front lawn.
- Coverage does not appear to be adequate at front walk zone. Recommend irrigation technician evaluate system further and repair all affected areas as needed for proper coverage.

Coverage issue.
